Hot Repairs in Coke Batteries under operation

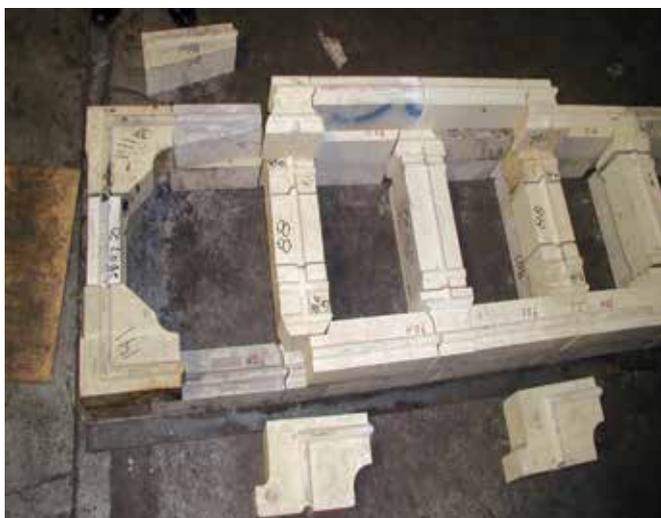
Fig.1: lay-out of a heating wall combined of liners and binders

A heating wall consists of a number of individual bricks joined together vertically and horizontally with mortar. These joints will crack first when movement at the bricks occurs. The movement can be caused by forces, such as the swelling pressure and/or friction of the coal, introduced during pushing from the pushing ram and the moving coke, particularly during a hard or unequal or nonlinear push as well as forces introduced by thermal shock.

The heating wall bonds and, in particular, the connection between the liner and the binder is of great significance for the stability of the coke ovens. To keep the integrity and the stability of the heating walls and the therefore the whole battery regular inspections as well as the maintenance particularly of the mechanical anchorage system is essential.

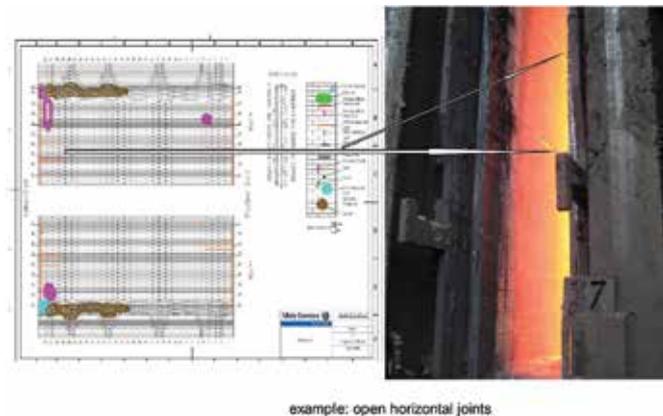
Fig. 2: Inspection sheet shows damages in the heating wall

At reasonable intervals, a refractory and mechanical specialist should make a thorough inspection of each oven. Damages must be recorded on special inspection sheets. The kind and area of damage has to be reported graphically using the given symbols. In addition, the battery can be scanned by means of 3D- Scan to examine the dimensional changes and extensions of the battery. An additional drone flight will also provide information about hot spots, leakages, the mechanical integrity and possible gas

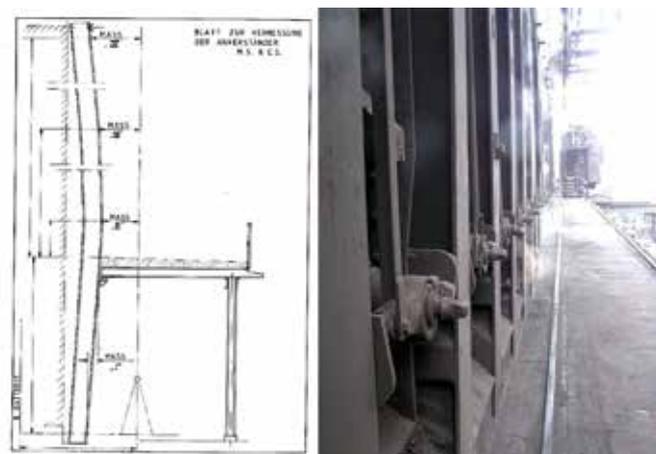
Fig.3: Measurement sheet for the buck stay alignment

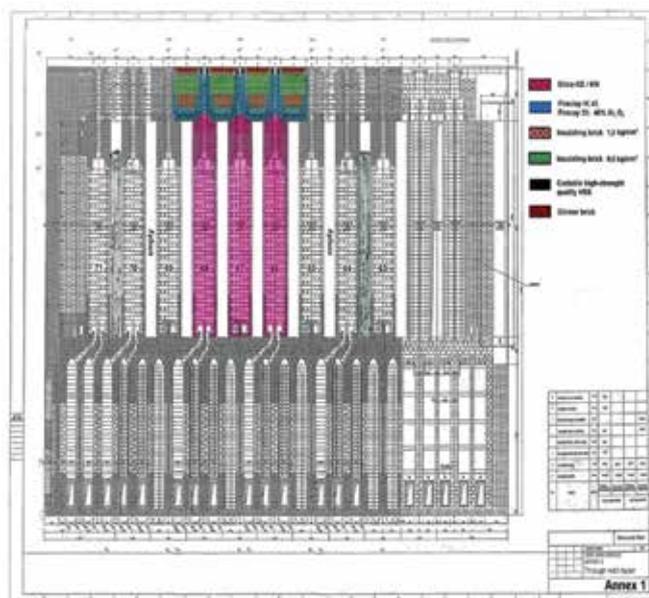
Figure 4 shows the break lines for an endflue repair of 3 heating walls.

As can be seen it is necessary to keep 4 ovens empty and for safety reason and a better heat control, the adjacent oven chambers are also empty.

Fig. 4: Repair breaklines for a wall repair incl. roof area

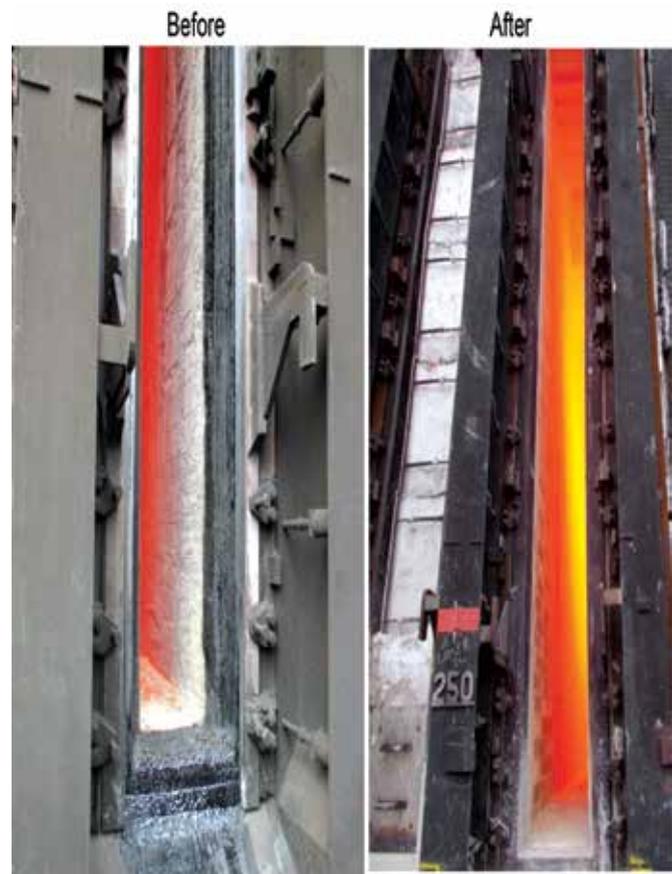
Fig. 5: Constitution of heating wall before and after a repair
